Technical Bulletin: eSet® Liners for Pro Series Style meters

January 17, 2011

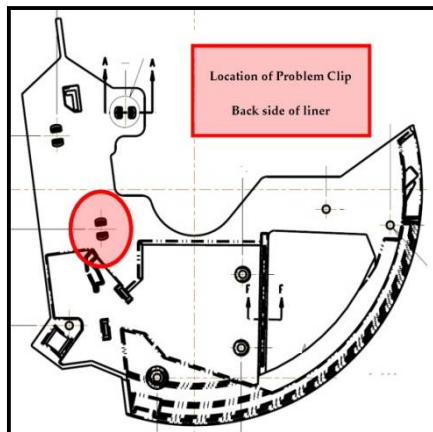
Problem: Due to a failure in our production mold, one batch of eSet liners for Pro Series meters has a molded clip with a deformed prong. This prevents the clip from locking into the housing.

Details: The deformed clip is easily identified. As shown below, just look at the back of the liner and locate the clips highlighted in the drawing.

The tabs should look like the ones in this picture.

The deformed tabs have a solid base that will prevent them from clipping into the liner as shown here.

We will ship replacement liners as soon the mold is fixed and they can shoot new liners – probably two weeks.

Please inspect your eSet kits and use the form on the back of this bulletin to let us know how many you need for replacement. We do not need the defective liners back . . . we just ask that you destroy them.
